REPORT OF APOLLO 13 REVIEW BOARD

**APPENDIX B - REPORT OF MISSION
EVENTS PANEL**

**APPENDIX C - REPORT OF MANUFACTURING
AND TEST PANEL**

APPENDIX D - REPORT OF DESIGN PANEL

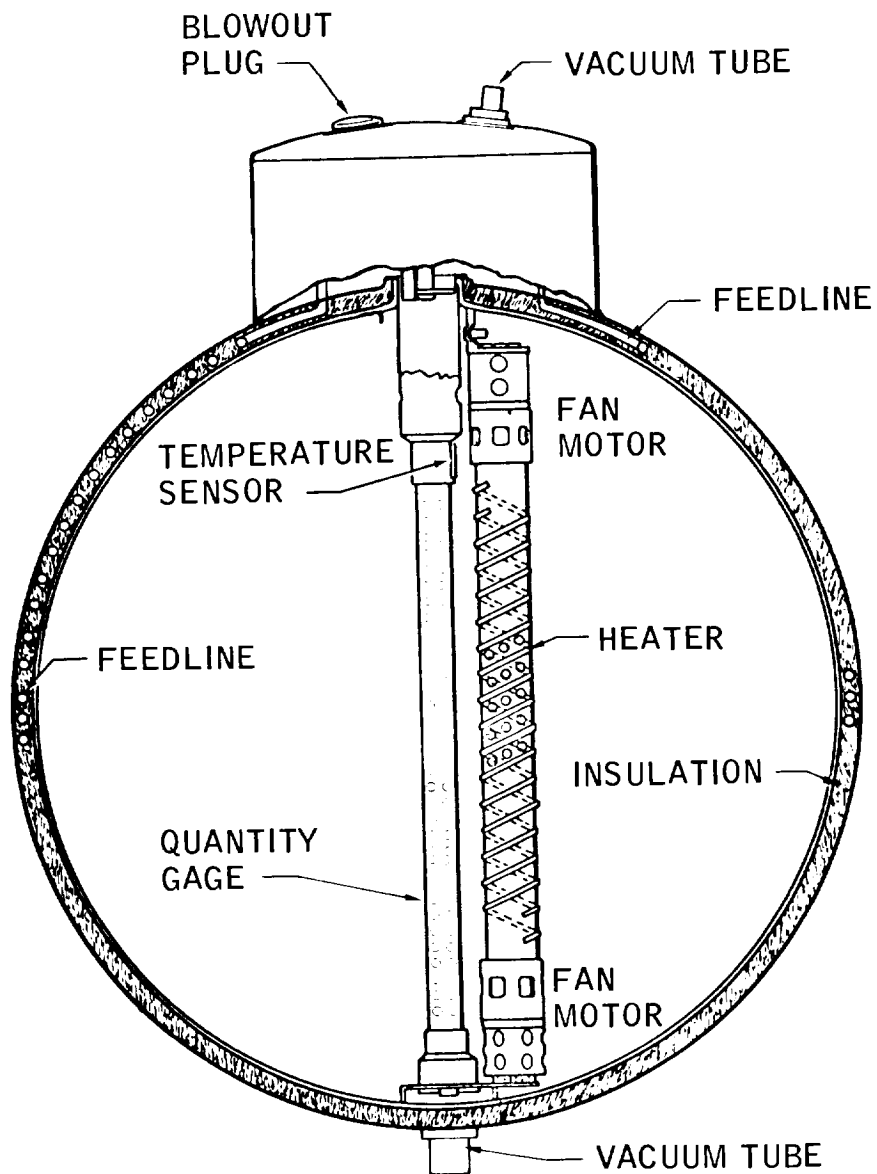
Figure B4-11.- Arrangement of components within oxygen tank.

At 47:40:08 the oxygen quantity changed from approximately 82 percent to 100 percent, or full-scale high. This change in reading or quantity system malfunction occurred just after or at the time the oxygen tank no. 2 fans were turned on. Because of the way the system recovered at the time of the accident, the data indicate that the probe or its associated wiring shorted. Since the instrumentation system was in low bit rate, it is possible to determine exactly when the oxygen

tank no. 1 and no. 2 fans were turned on. The electrical data indicate that the oxygen tank no. 1 and no. 2 fans were turned on between the times of 47:40:05 and 47:40:08. A plot of cryogenic pressures, quantities, total CSM current, and ac main bus 2 is shown in figure B4-12. Therefore, the oxygen tank no. 1 and no. 2 fans were turned on in a period of time between 3 seconds prior to the probe malfunction and the time that the probe malfunctioned.

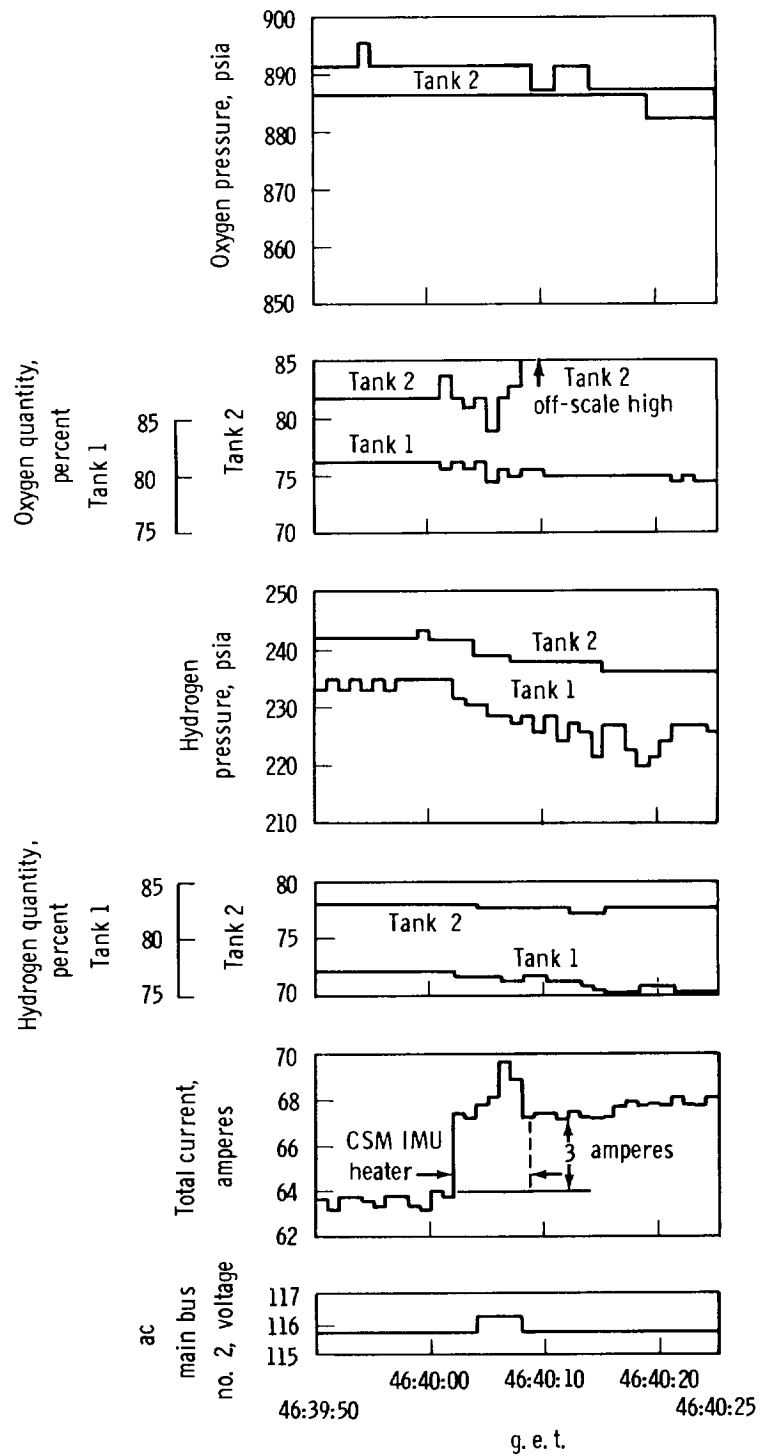
Figure B4-12.- Fan cycle at 46:40.

When the oxygen tank no. 2 fans were turned on the next time at 47:54:50, the ac main bus 2 decreased 1.8 volts for one sample (0.1 second). At the same time the TVC command parameters indicated a negative initial transient. Because of the sampling rate (10 samples per second) of the instrumentation system and the small number of fan cycles examined in the high bit rate mode, it cannot be determined if this negative initial transient is characteristic of other fan turnon's or is an indication of a deteriorating fan or wiring.

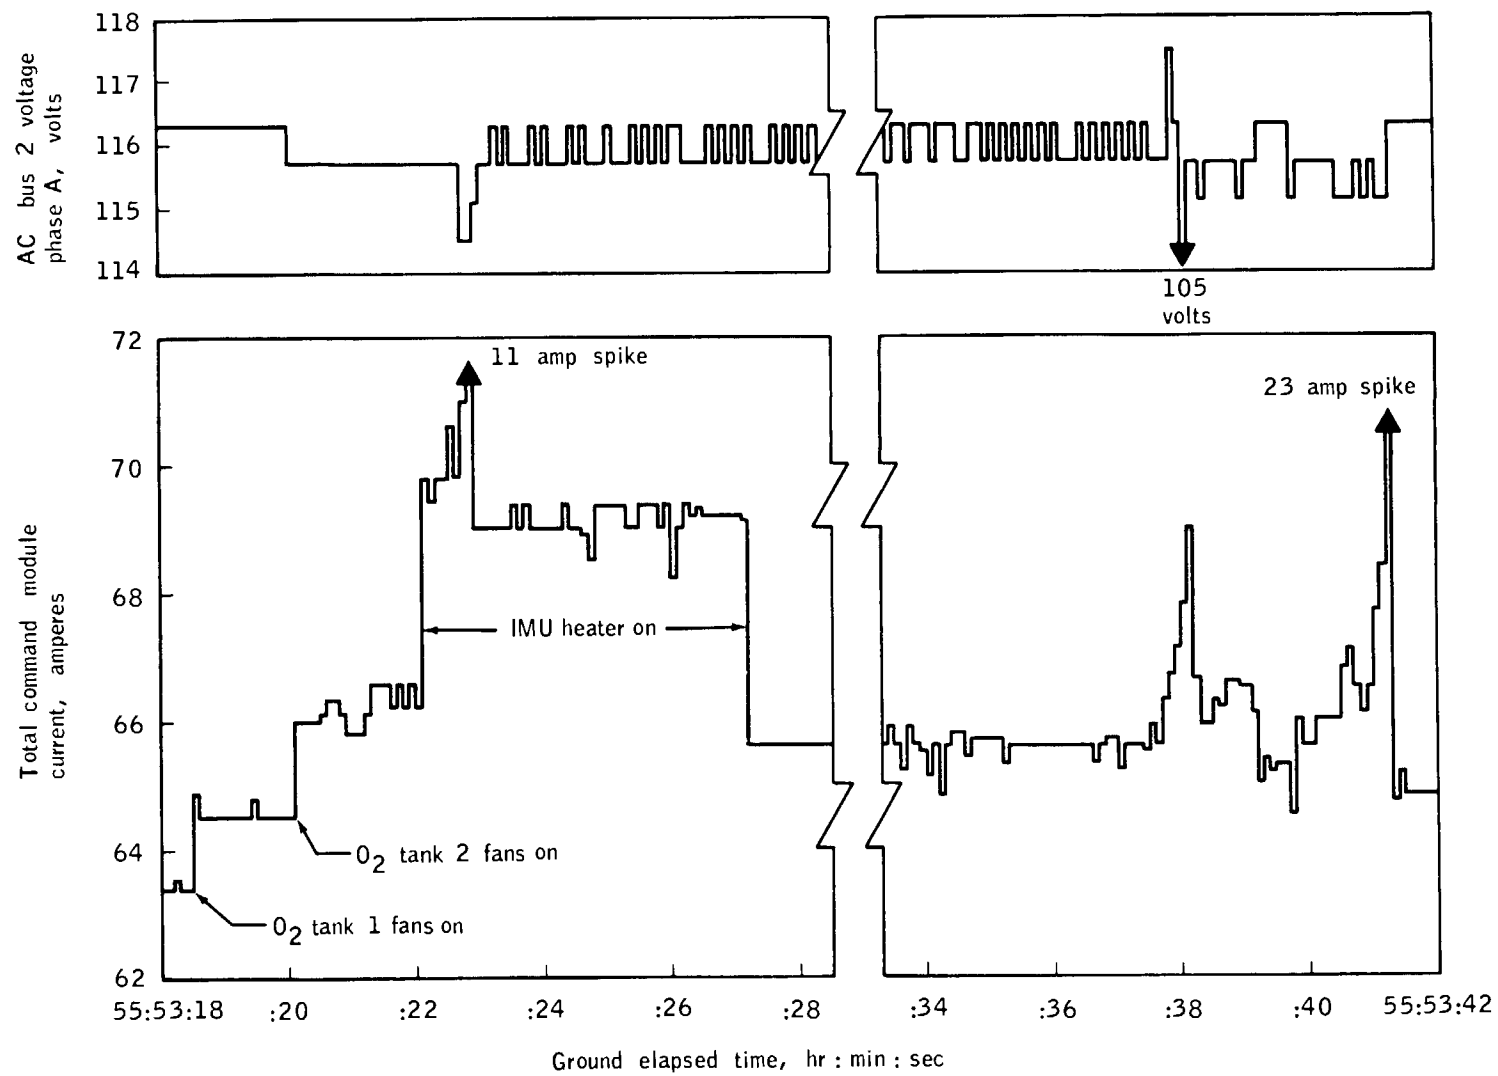
Figure B5-4.- Electrical anomalies.

voltage of 0.6 volt, and a glitch in the stabilization control system telemetry indicated that the fans had been electrically energized. These events are shown in figures B5-4 and B5-5. However, it is not certain that the fans began rotating at this time, since the tank no. 2 pressure showed a minimum observable drop and the fan motor stall current does not significantly differ from the running current. The quantity gage in tank no. 2 was already in a failed condition, and the fuel cell flowmeters were already being affected by the fan operation in tank no. 1. so that neither of these instruments could positively verify rotation of the fans in tank no. 2. During the next 20 seconds a series of electrical anomalies occurred which cannot be explained as a result of known loads in the spacecraft. These anomalies are shown in figure B5-4. The first, at 55:53:23 was an 11-amp positive spike in the output current of fuel cell 3. Several events were associated with this spike:

The most probable cause of the electrical disturbances between 55:53:22 and 55:53:42 is that a short circuit occurred in the electrical

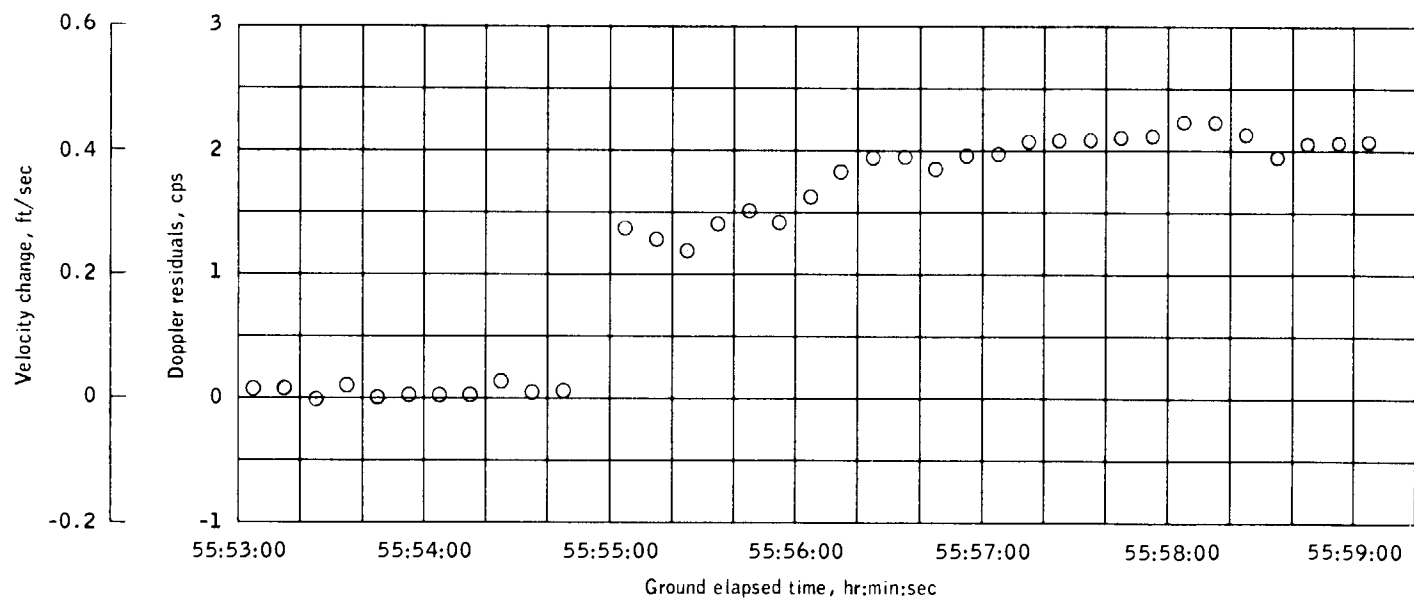
Figure B5-12.- Velocity increment at 55:54:53.

Between 55:54:45 and 55:55:05 doppler measurements indicated a radial velocity increment of 0.26 fps. This is shown in figure B5-12. Following this abrupt change in velocity at approximately the time of telemetry loss, additional velocity changes were observed, as shown in figure B5-13. These velocity increments were caused in part by venting from the spacecraft and in part by firings of reaction control system jets.

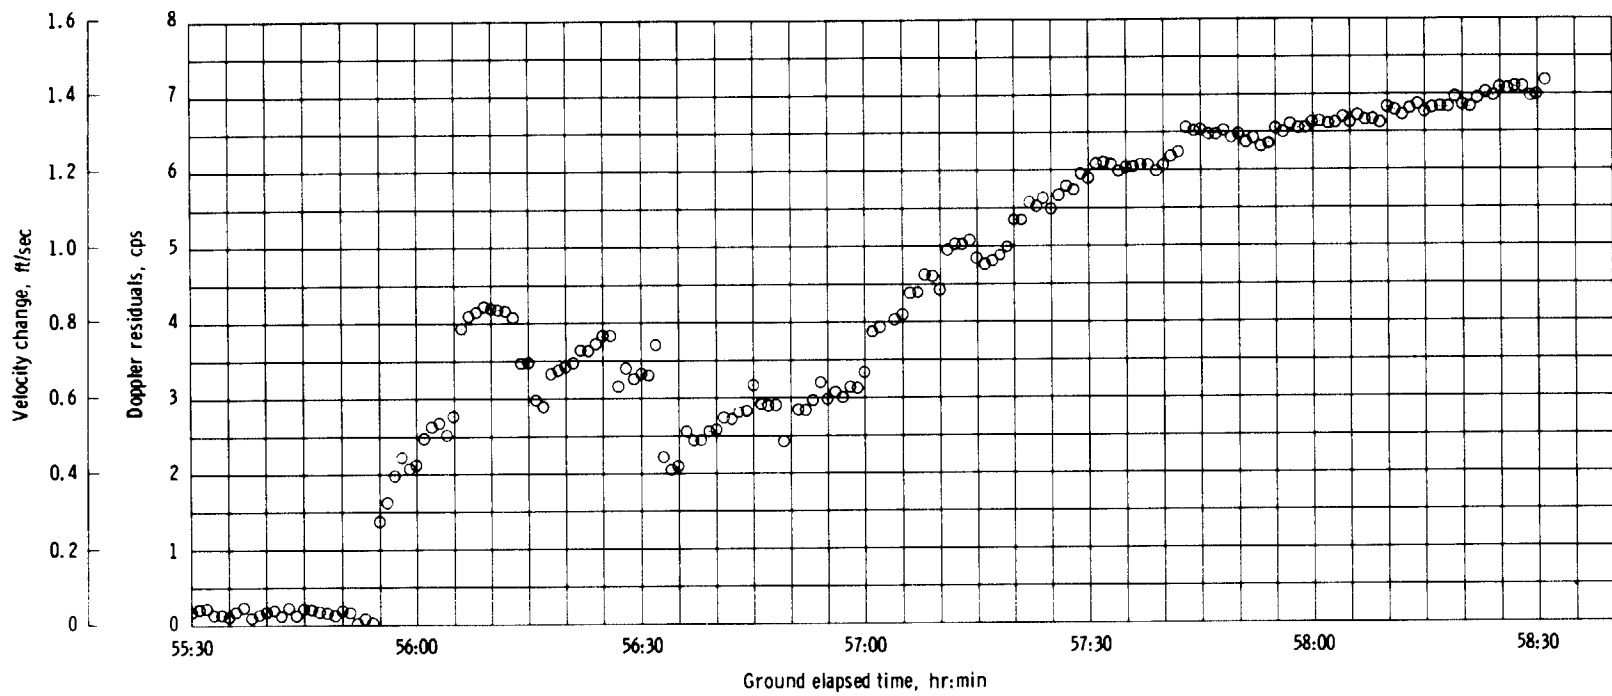
Figure B5-13.- Doppler tracking data.

The jet firings caused velocity increments rather than pure rotation rate changes because the jets did not always fire in opposed pairs. This resulted from the power system configuration in the spacecraft and closure of the quad C valves. (See Part B6 of this Appendix.)

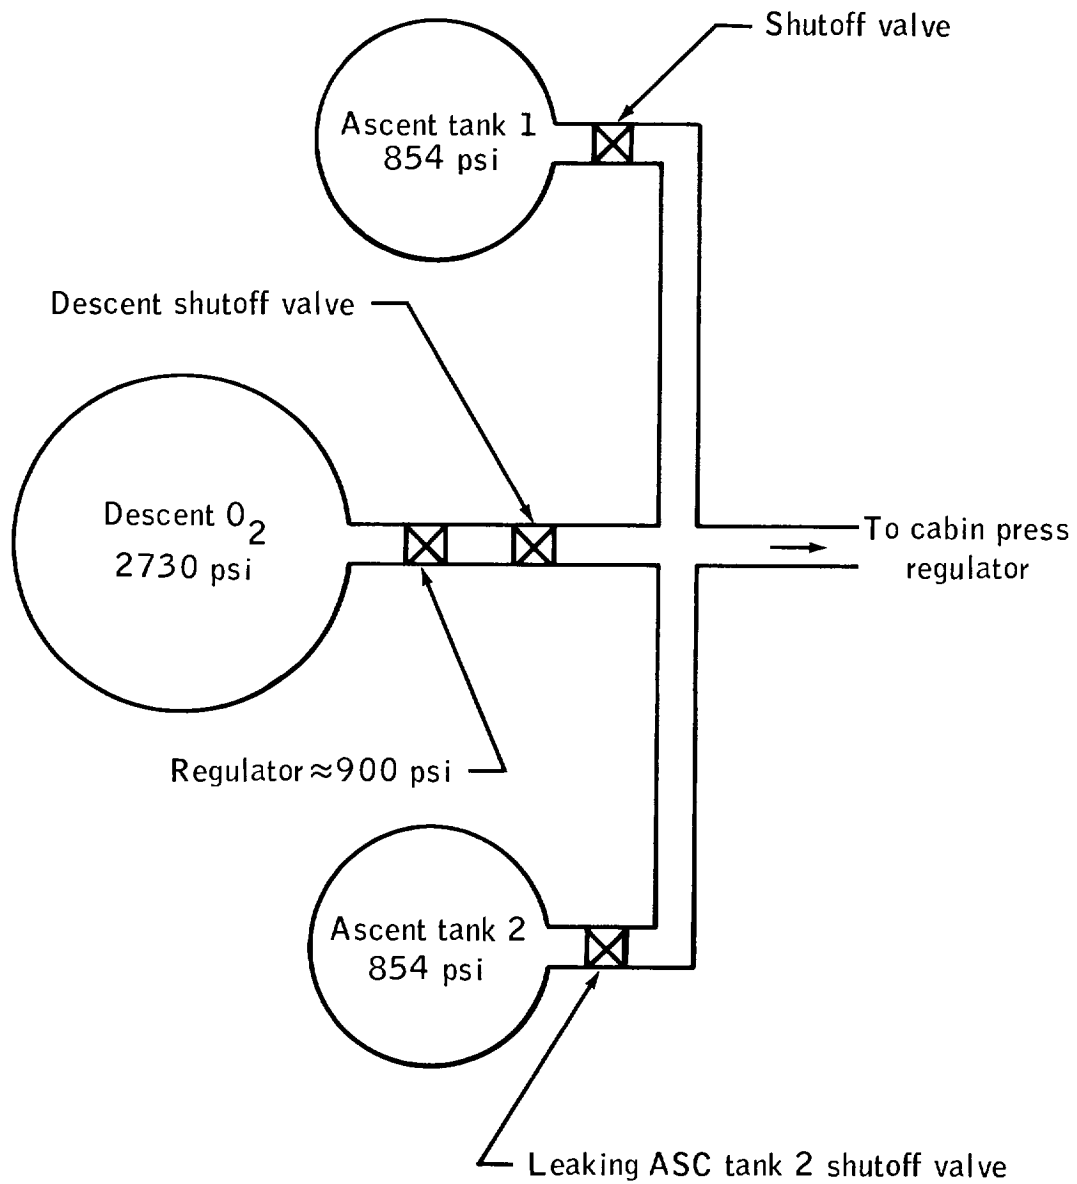
Figure B6-3.- Schematic of LM oxygen storage system.

An abnormally high pressure reading was noted in one of the LM ascent stage oxygen tanks shortly after telemetry data were received in Mission Control, and the crew was directed to use oxygen from this tank instead of the descent tank. Later it was diagnosed that the shutoff valve leaked, allowing the higher pressure oxygen from the manifold to leak into this ascent tank. The condition in itself was not a problem; the net effect was that this ascent tank was raised to a slightly higher than normal pressure which was well within the tank limits. This degraded the system redundancy, however, and had a subsequent leak developed in this tank, the LM oxygen supply would have been depleted (fig. B6-3).

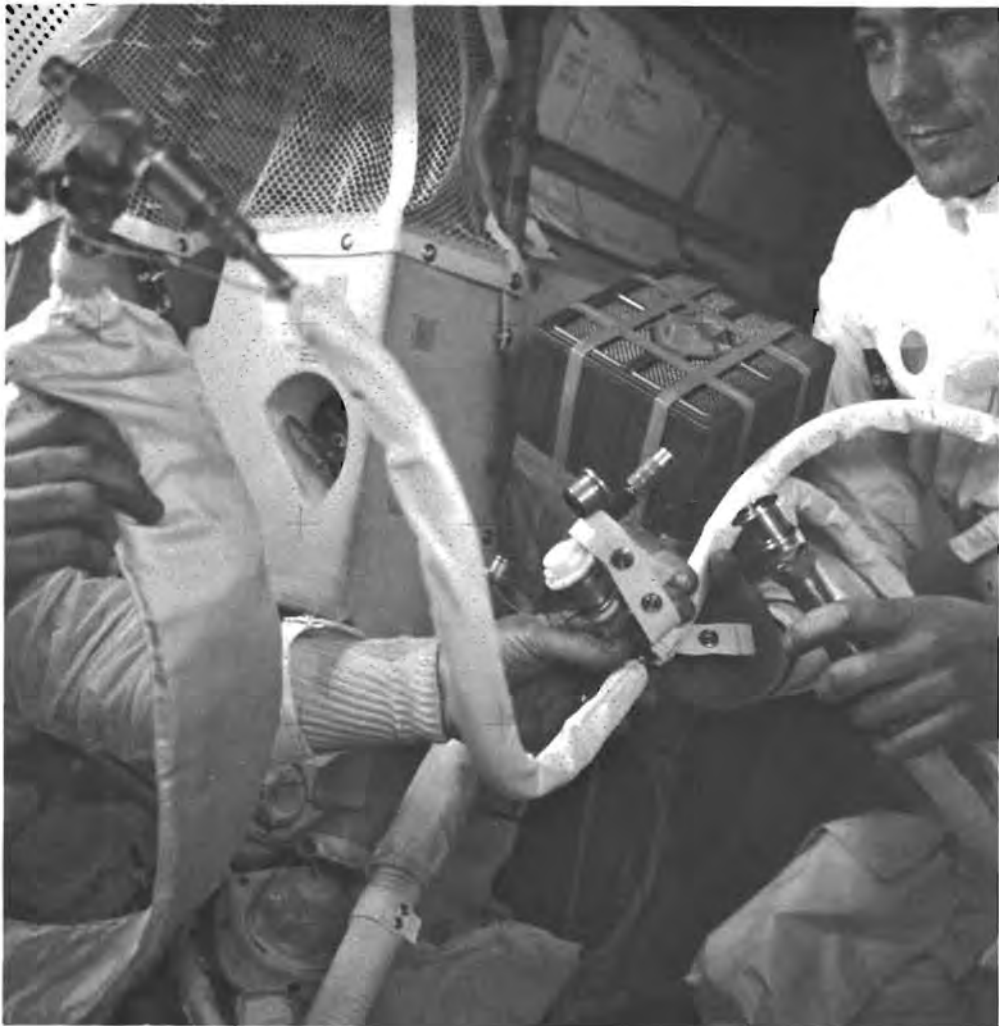
Figure B6-7.- View of CM LiOH cannister modification as installed in the LM.

The problem of removing carbon dioxide from the cabin oxygen was a serious one. The LM, like the CSM, uses lithium hydroxide (LiOH) cartridges to scrub the recirculated oxygen to remove odors and carbon dioxide. The LiOH cartridges are rated for a specified total man-hours capacity, and eventually must be replaced when they become saturated. The LM cartridges were not adequate for carbon dioxide removal for three men for the duration of the Earth-return trip. There were more than adequate cartridges in the CM, but they would not fit in the LM canisters. There were several methods suggested for solving the problem, including powering up the CM system to circulate cabin oxygen through its LiOH canisters. The method that was actually used was developed by Crew Systems Division personnel at MSC. It consisted of using tape, flight data file cards, and plastic bag material to connect the CM LiOH canisters to the LM oxygen circulation system. The crew implemented the modification and it worked very well. The partial pressure of carbon dioxide reading indicated by the onboard gage dropped rapidly from 8mm Hg to 0.1mm Hg soon after the rig was completed at 94 hours g.e.t. The modification was not tried until this time in order to get maximum use from the LM cartridges. About 20 hours later, the carbon dioxide partial pressure reading had increased to 1.8mm Hg, and a procedure for putting two additional cartridges in series to those in the CM canisters was given to the crew. This procedure was also developed by engineers at MSC (fig. B6-7). After this second modification was completed, the carbon dioxide partial pressure remained below 2mm Hg for the rest of the mission, without any further modifications necessary.

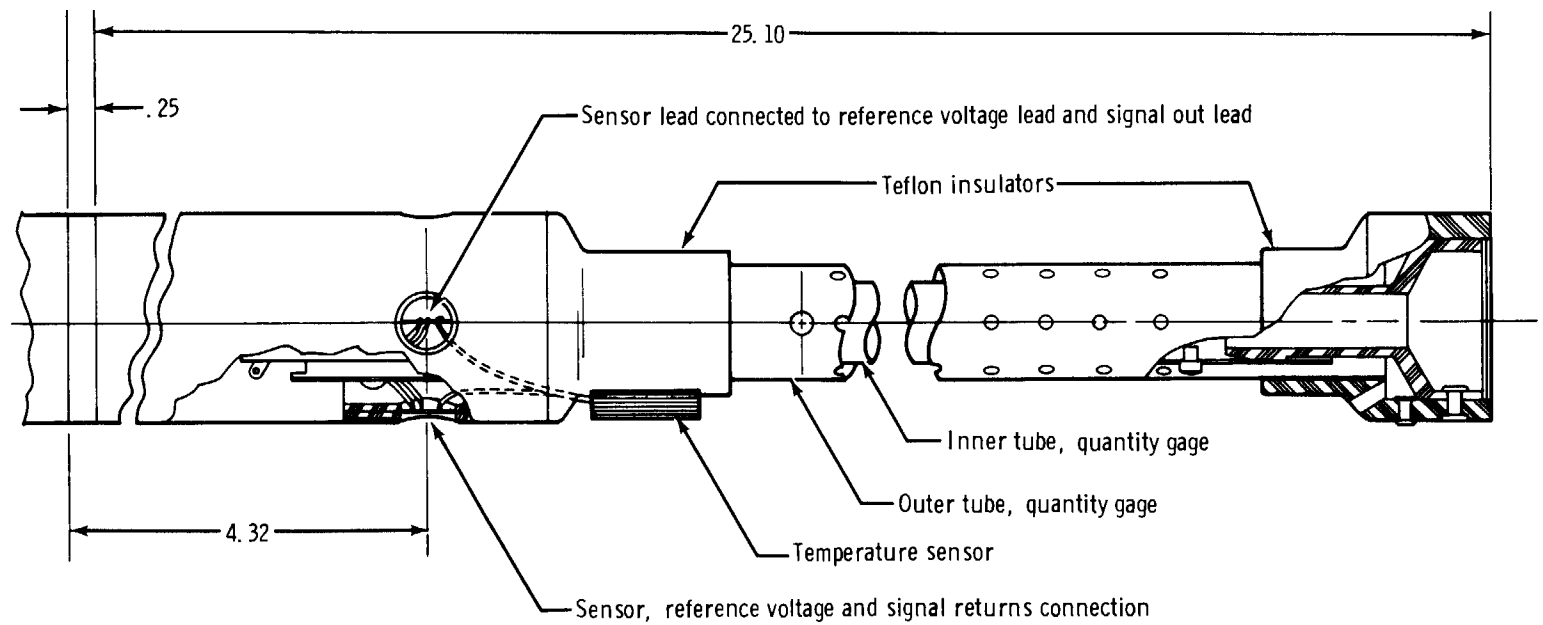
Figure B7-1. - Oxygen quantity gage and temperature sensor location.

The temperature measurement is made with a platinum resistance thermometer (R/T) encased in an Inconel sheath attached to the Teflon insulator part of the quantity probe (fig. B7-1). The resistance of the R/T and the transducer output voltage increase with temperature. The signal conditioner which serves as a reference voltage generator and amplifier is located on the oxygen tank shelf. An electrical schematic of the transducer is shown in figure B7-2.

Telemetry would indicate the temperature of the sensor itself, but under rapidly changing conditions the sensor could remain almost unaffected by local temperature changes in other parts of the tank. The effect of various failure modes on the transducer and its output signal are presented in table B7-I.

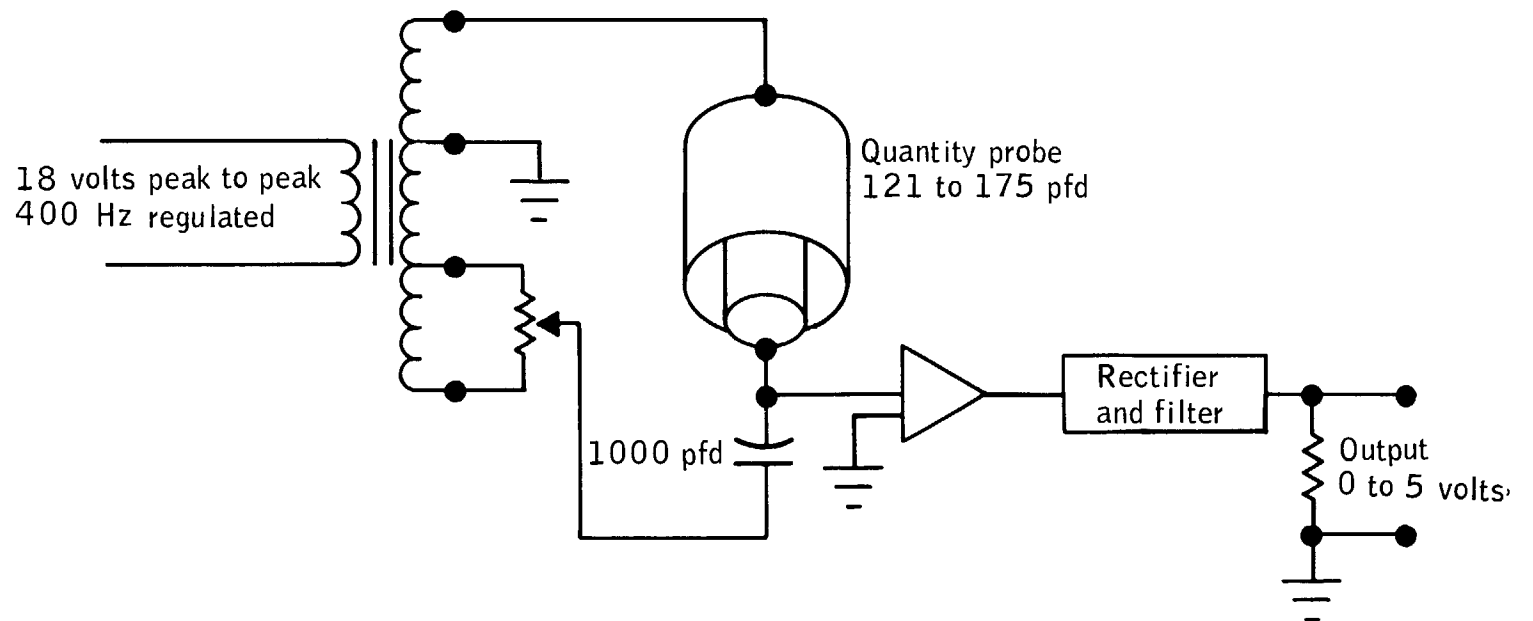
Figure B7-3.- Oxygen quantity gage block diagram.

This method of gaging works well for single-phase fluids in any gravity environment so long as the fluid is uniformly mixed with no significant density variations. But under zero-g, density and temperature variations can exist in the fluid, especially when heat is added without any fluid movement (convection). Under these conditions, the gage measures the average density of the oxygen between the two tubes which may or may not be representative of the average density in the tank.

If the gage is either opened or shorted, the signal conditioner is overdriven and a greater-than-100-percent quantity is indicated. Other malfunction characteristics follow.

<u>Failure Mode</u>	<u>Effect</u>
1. Elements of probe shorted to each other	Full scale output
2. Wire to either element disconnected from probe	Full scale output
3. Outside element of probe or its lead wire shorted to ground	Measurement indicates some value between zero and full scale
4. Inside element of probe or its lead shorted to ground	Random output tending towards zero
5. Clear shorted probe	Output decreases to zero, remains 0.7 second, then increases to correct value in about 1-1/2 second
6. Clear open probe fault	Output assumed correct value within 1/2 second
7. Intermittent shorts, any combination	Output becomes irregular sawtooth

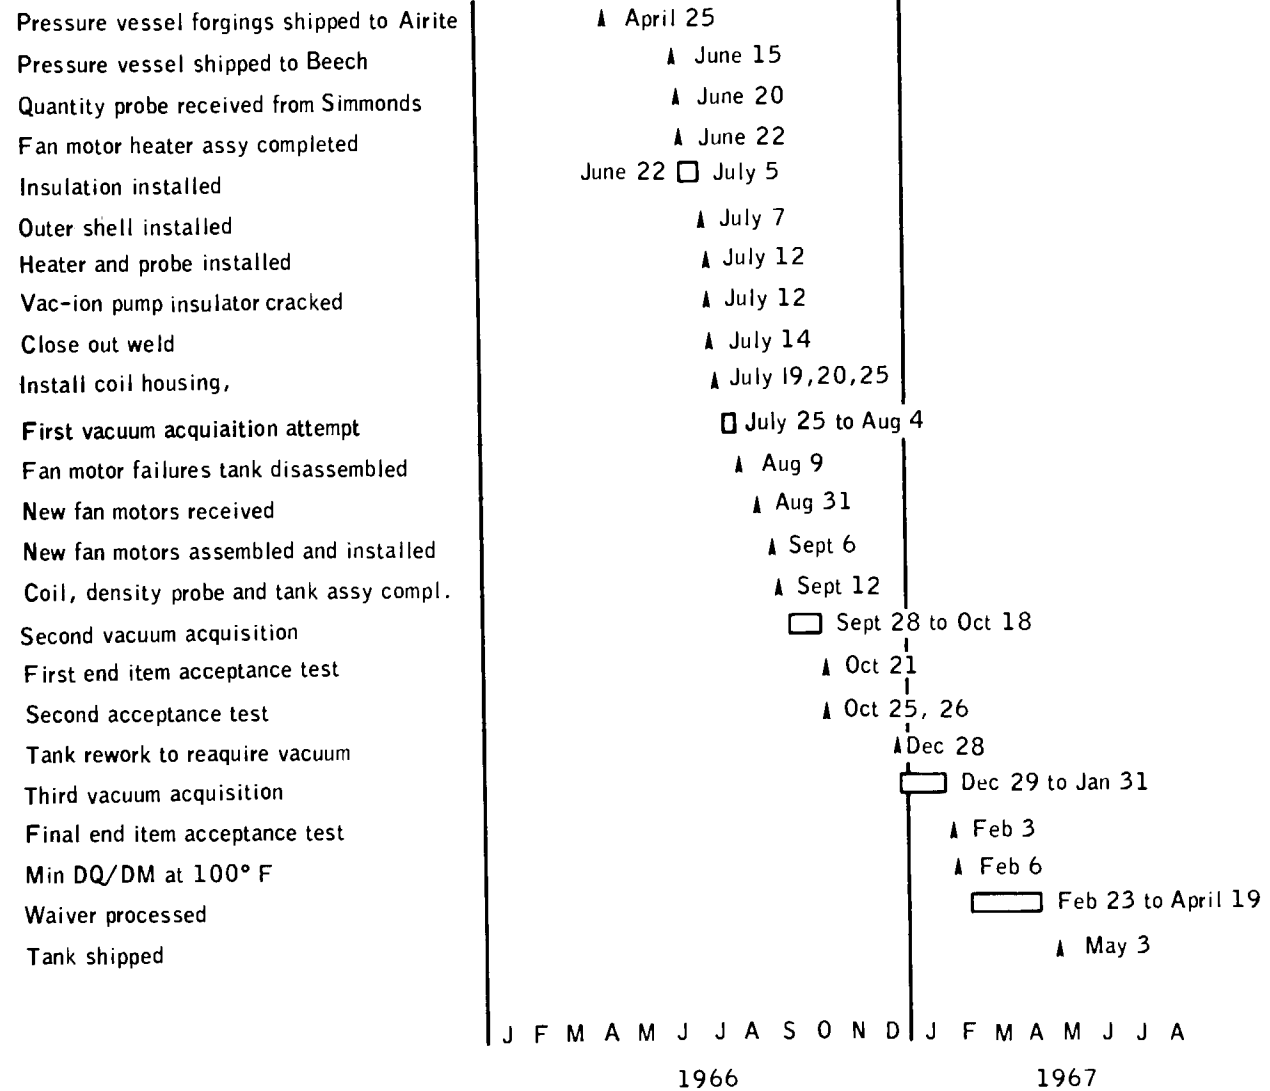
The manufacturing and test flow for cryogenic oxygen storage tank serial no. 10024XTA0008 is shown in figure C4-48. The item of particular significance is the recycle that was required in the manufacturing process brought on by motor failures.

A listing of the inspection discrepancies issued against serial no. 10024XTA0008 are listed in table C4-I. In the Beech nomenclature these discrepancies are known as Withholding Forms. As stated previously, the motor problem is considered the significant item. The heat-leak problem was not considered serious because many missions required use rates above the minimum flow capability of tank 0008.

Figure C4-48.- Manufacturing and test flow for the oxygen tank at Beech.

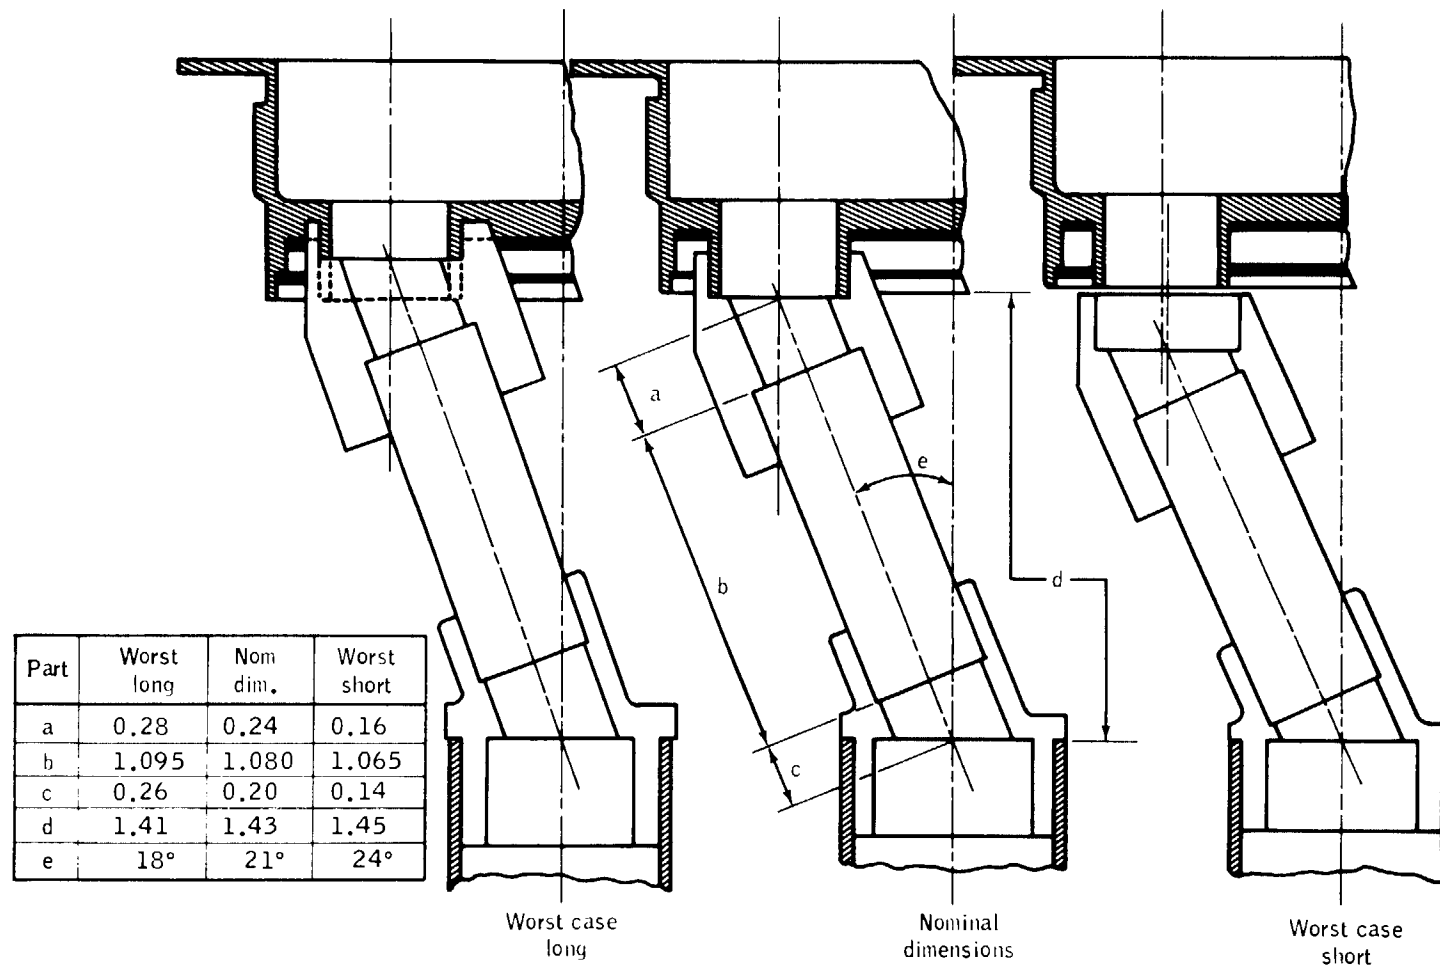
In addition to the tolerance condition that can exist for the fill tube connecting parts, the center tube of the quantity probe could move downward due to Teflon cold flow. The center tube is supported in the axial position by two Teflon bushings installed in the center tube and a semi-tubular rivet. Prolonged heating, such as the vacuum pumpdown cycles (three cycles for this tank assembly resulting in a total of 1532 hours at 190 to 220° F), could result in the thin walls of the center tube slowly cutting into the Teflon bushings.

Table C4-II shows the range of diametral clearances that can exist at ambient conditions (73° F) and at a typical detanking condition (-278° F, which corresponds to the saturation temperature of liquid oxygen at 40 psia). The fit between the Teflon bushing and the tank adapter fitting can result in a maximum 0.003-inch interference. The only other clearance that results in an interference fit occurs if the minimum size holes are provided where the Teflon bushings slide on the 3/8-inch Inconel tube. Tests at liquid nitrogen temperature (-320° F) indicate that the Teflon is not overstressed and does not crack when subjected to interference fits of this type.

Figure C4-49.- Extreme and nominal tolerance cases for fill tube connection parts.

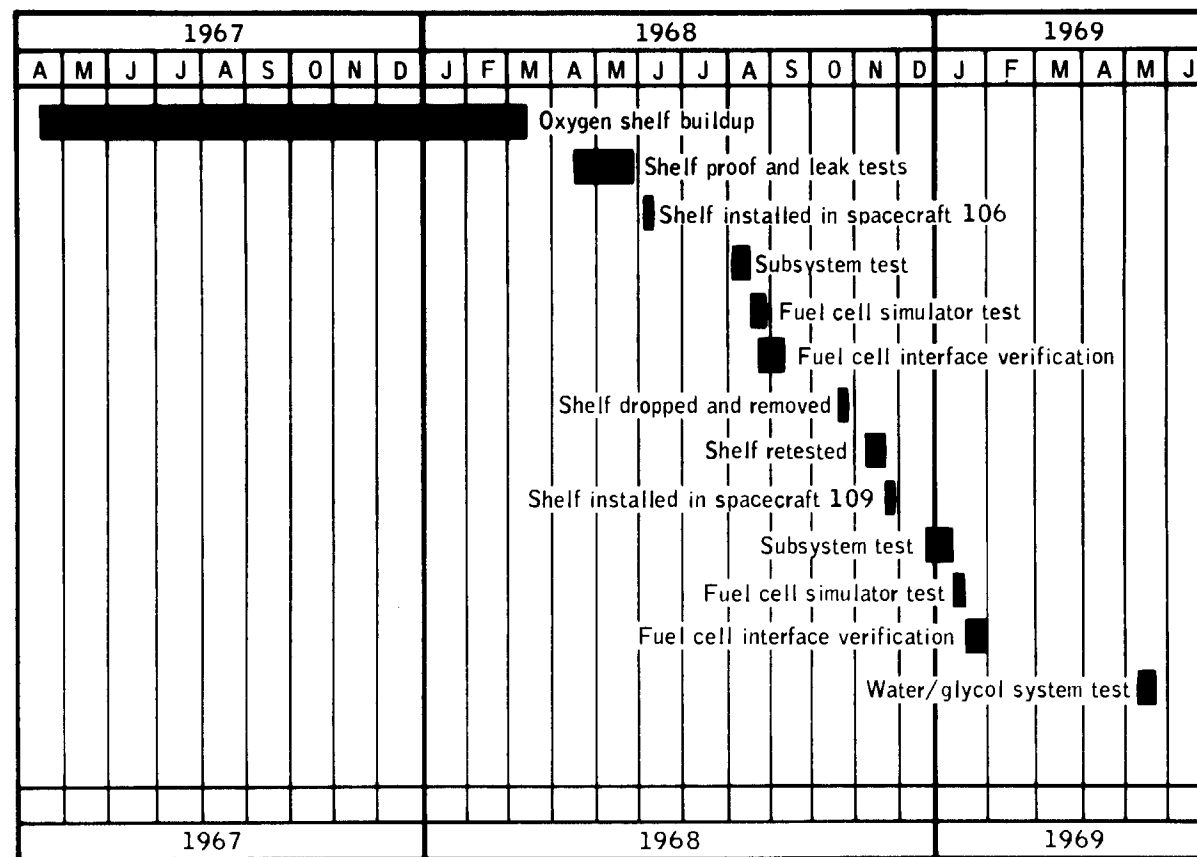
During April and May 1968, 11 disposition reports were written to log tank no. 2 anomalies found during proof-pressure, leak-check, and functional checkout of the assembled oxygen shelf. Eight of these were ascribed to test procedure problems, two to a valve module (check valve) tubing leak and one to an electrical connector pin. The leak was rewelded by a Parker technician and passed leak test. The pin was repaired by NR and checked.

After installation of this oxygen shelf in SM 106, eight disposition reports were written during installation, additional tubing connection and subsystem line proof-pressure and leak check, and electrical cabling checking. Of these, two problems with a hydrogen relief line mounted adjacent to the oxygen shelf were solved by making up new tubing and later reheating a brazed joint to meet X-ray control requirements. Three oxygen subsystem leaks were solved by retorquing caps and a "B" nut on oxygen lines leading to fuel cell no. 2. The three remaining disposition records expressed questions concerning leak and electrical function testing of the oxygen shelf assembly which were held open pending the next opportunity for shelf assembly testing.

Figure C4-52.- Manufacturing and test flow for the oxygen shelf.

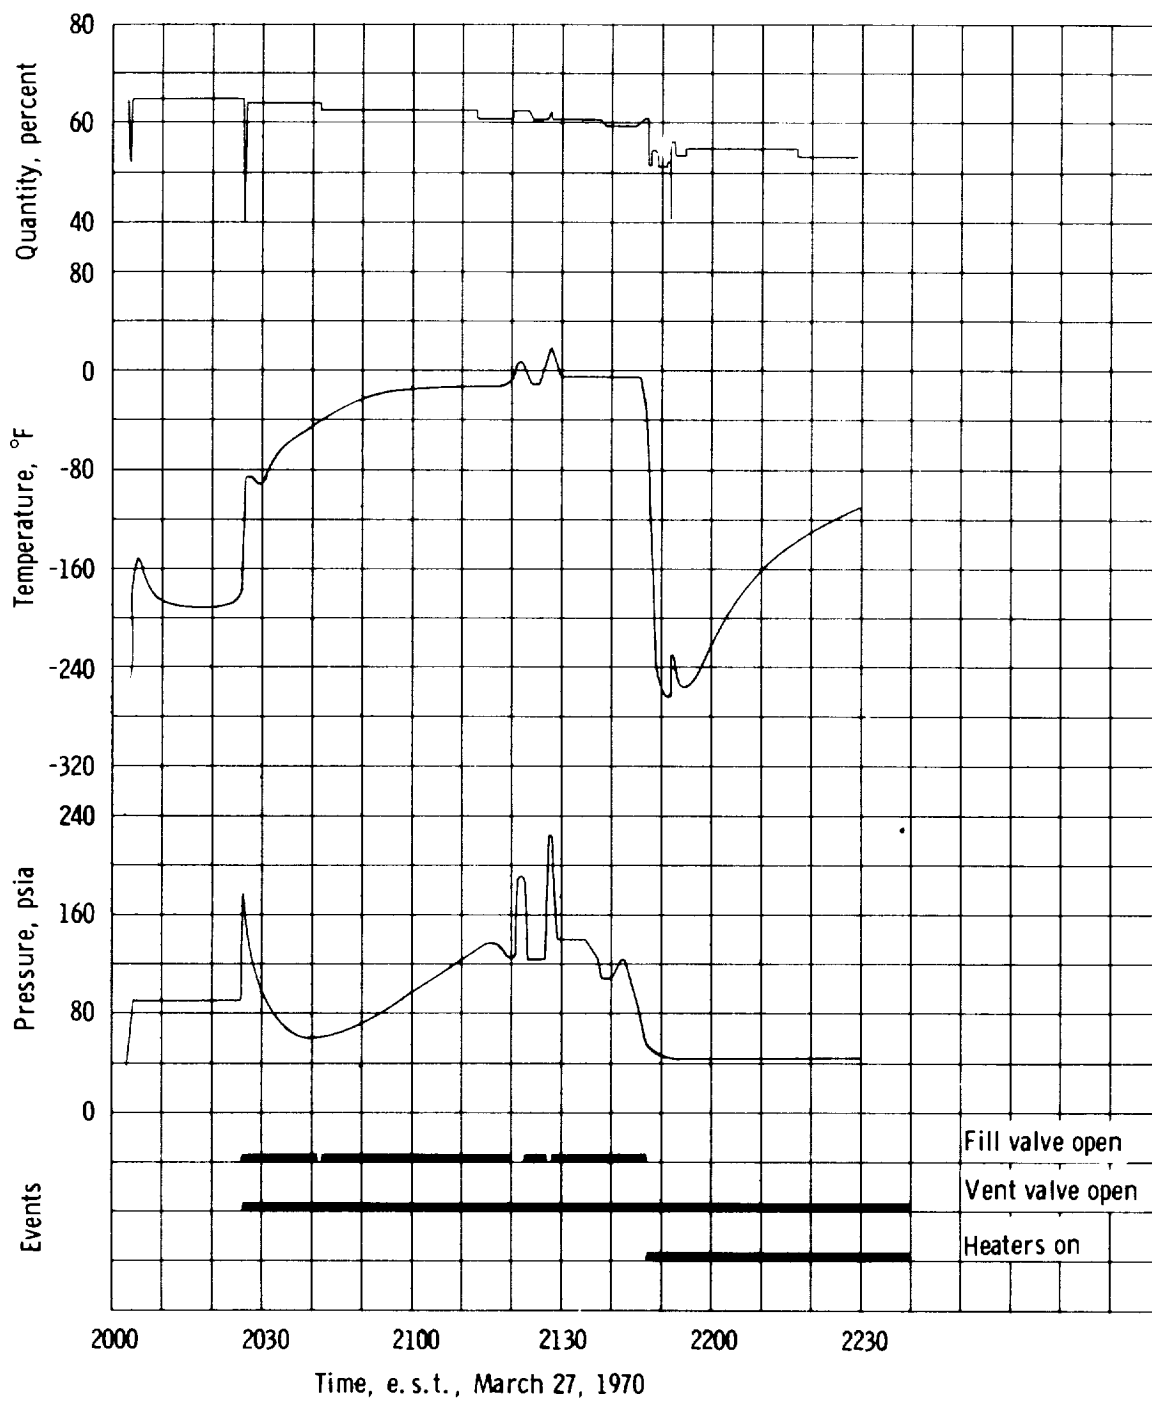
Attempts were made over an 80-minute period to deplete the oxygen content of tank no. 2 by cycling up to various pressures and down, but did not reduce the indicated quantity below 54 percent (fig. C4-59). An attempt was made to expedite oxygen expulsion through the use of the tank heaters operated at maximum voltage and the fans. These were turned on for nearly 6 hours while the vent port remained open (fig. C4-60). Still the indicated quantity remained above 30 percent.

Figure C4-59.- Oxygen detanking attempt using varying purge pressure.

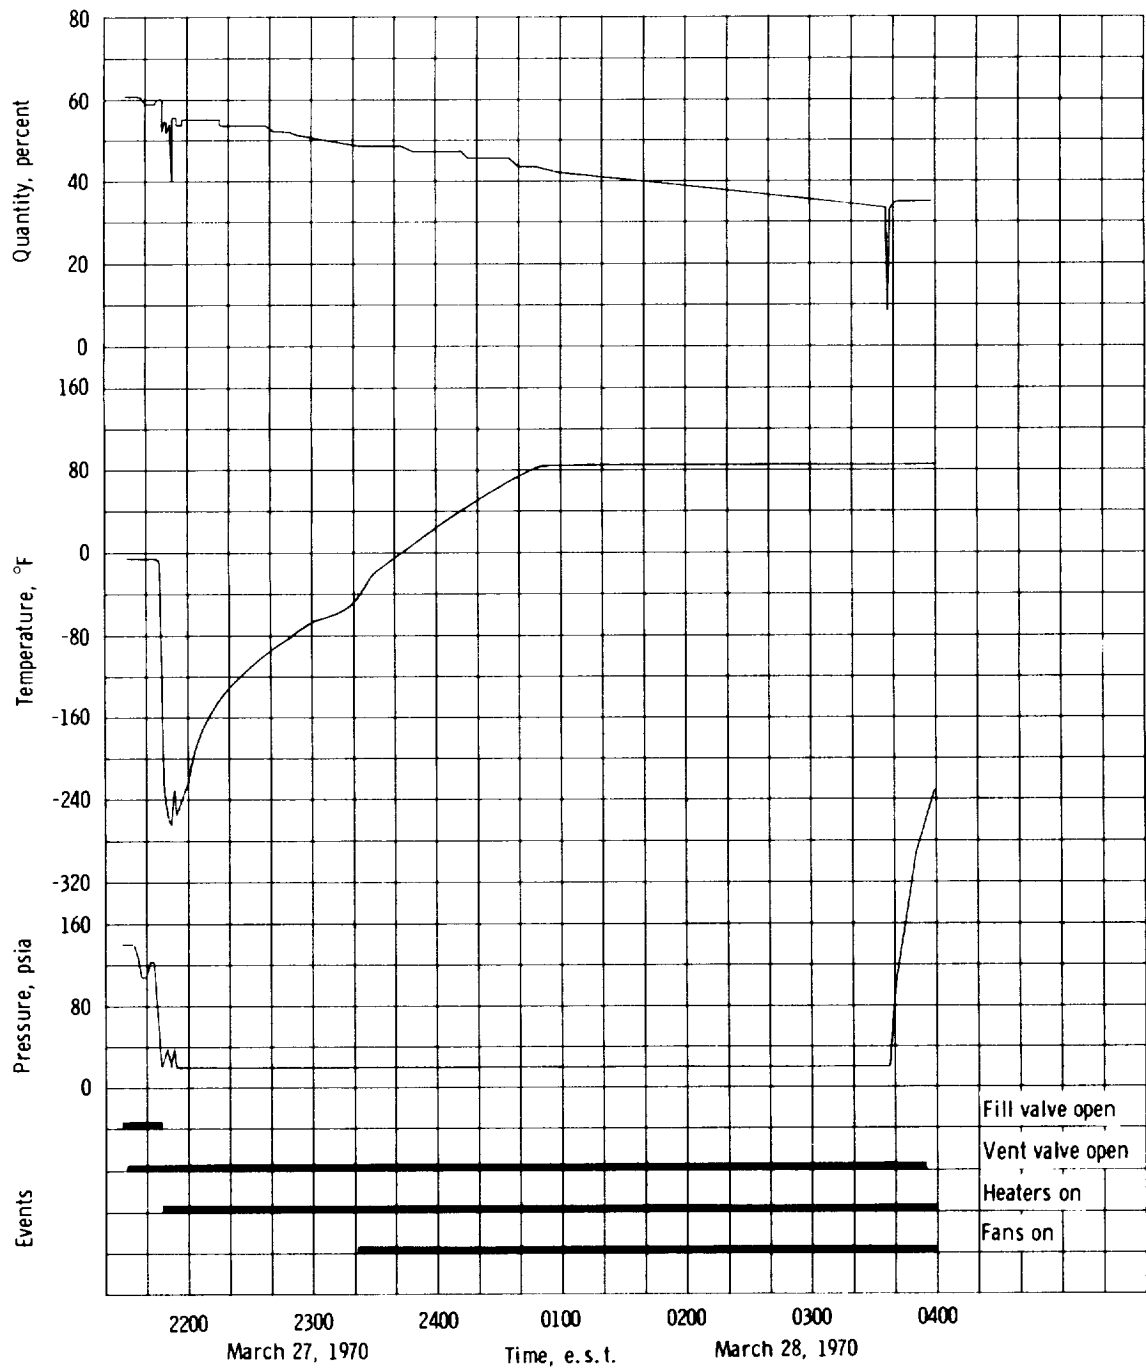
Figure C4-60.- Oxygen detanking attempt using tank heaters.

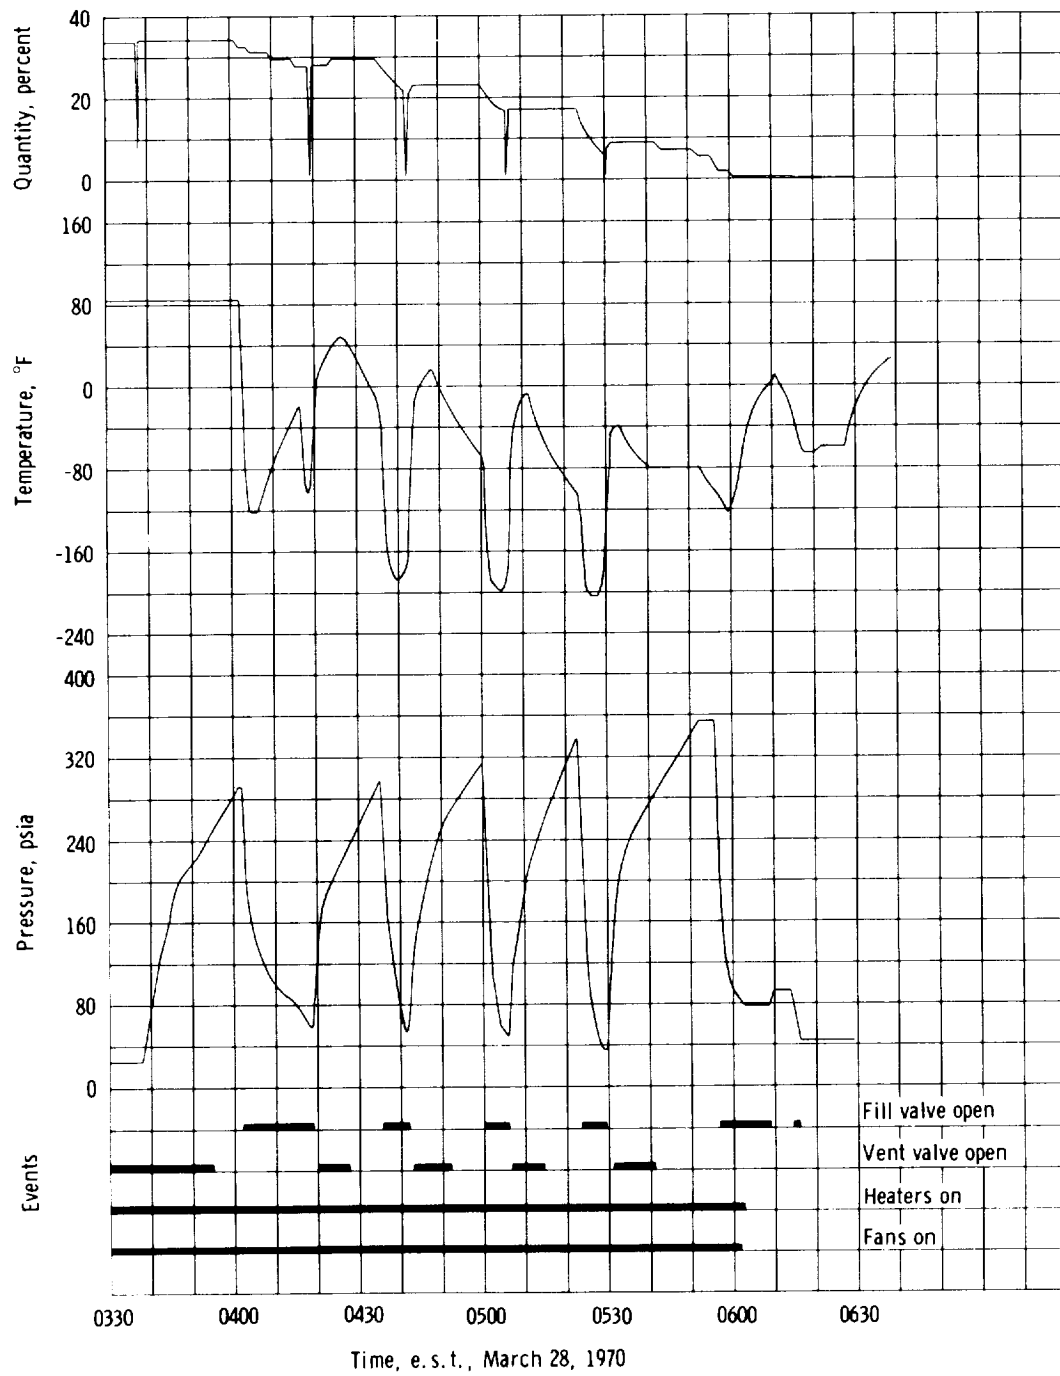
Then a pressure cycling technique was employed over a 2-1/2 hour period with maximum power being applied continuously to both tank heaters and fan circuits (fig. C4-61). This technique involved raising the tank pressure by external gaseous oxygen to approximately 300 psia and then opening the fill line to induce rapid boil-off. After five cycles, the oxygen tank quantity indicated zero.

Fan responses were observed to be normal throughout these operations. The temperature sensor on the quantity probe reached its indicating limit (+84 F) halfway through the 6-hour heating period. No observations of whether the heaters cycled on and off were made and subsequent review of the power supply voltage recording showed no indication of heater cycling.

Figure C4-61.- Oxygen detanking using pressure cycles and tank heaters.
